## TEST REPORT - Translation

### No. 15-7042

**Test Specimen:** Outdoor Case Type 5000

By means of a laboratory simulation an outdoor case -type 5000- is to be tested to transport strains. The tests should be performed according to the specification of the client, based on ATA 300. The final analysis will be performed by the client.

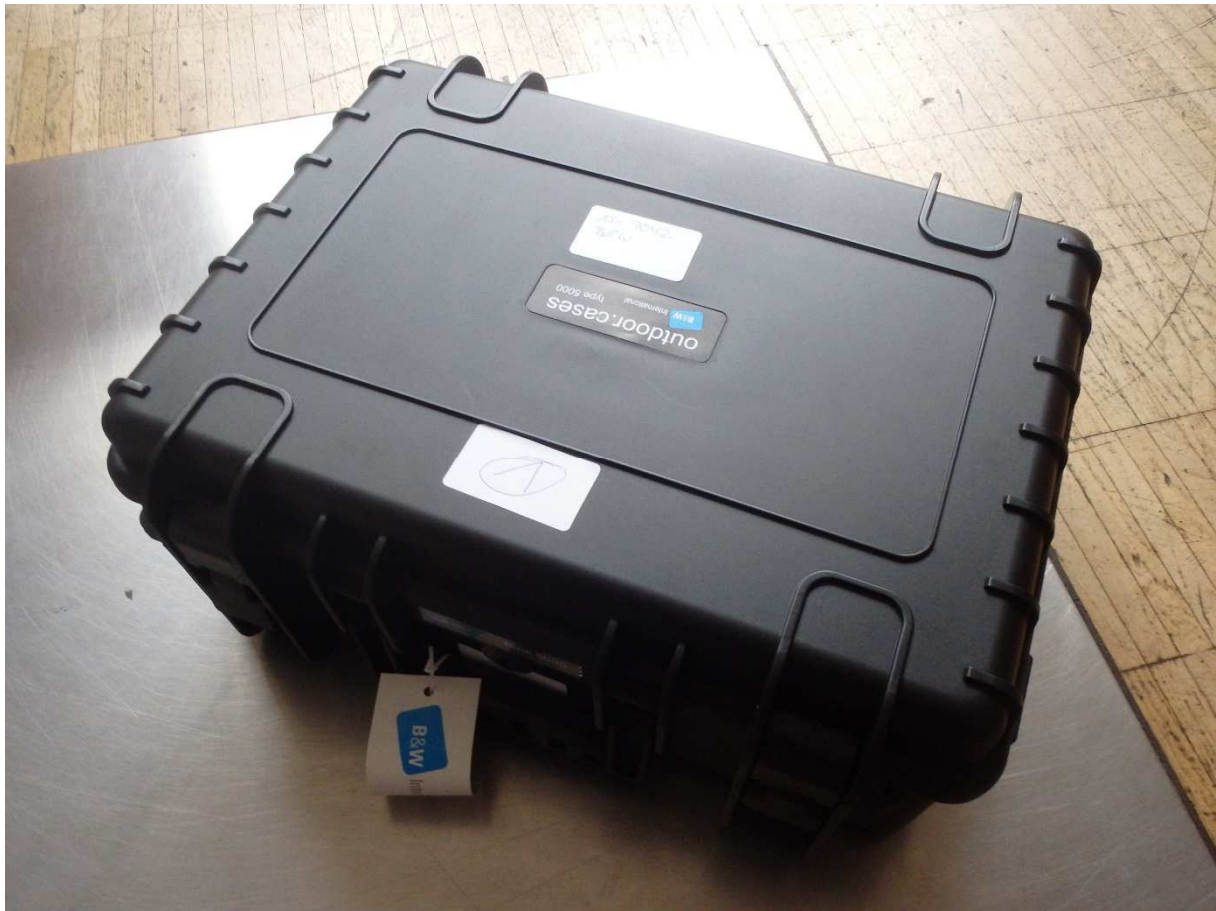
**Illustration 1: EUT**

The incoming goods control showed no visible damages at the case (see illustration 1).

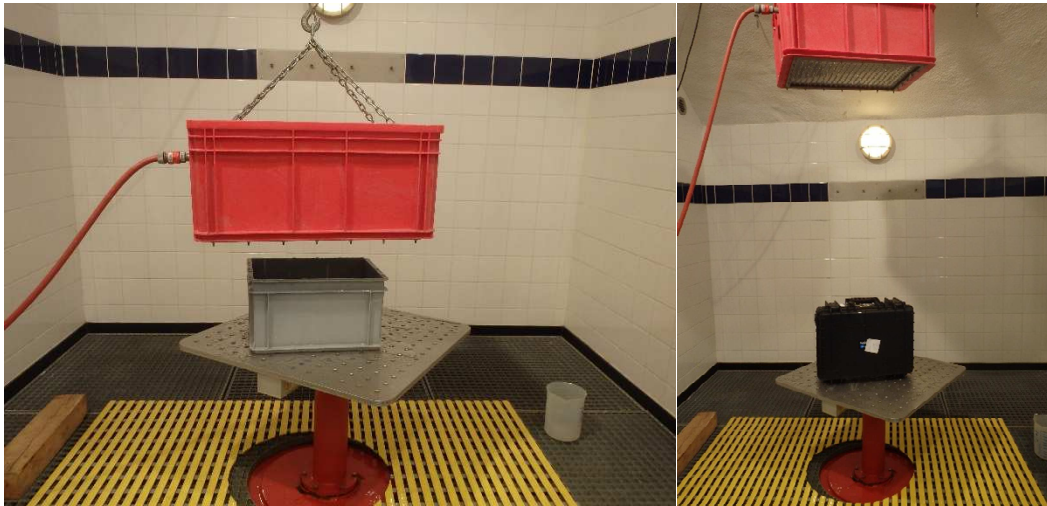
**Illustration 3:** Test Setup Drip Proof Test and Calibration

The drip proof dispenser was placed 1 m above the specimen. The flow rate was 140 l/m<sup>2</sup>/h. The water flow rate was calibrated before testing. The test duration was 15 minutes. Illustration 3 and 4 shows the calibration of flow rate and the setup.

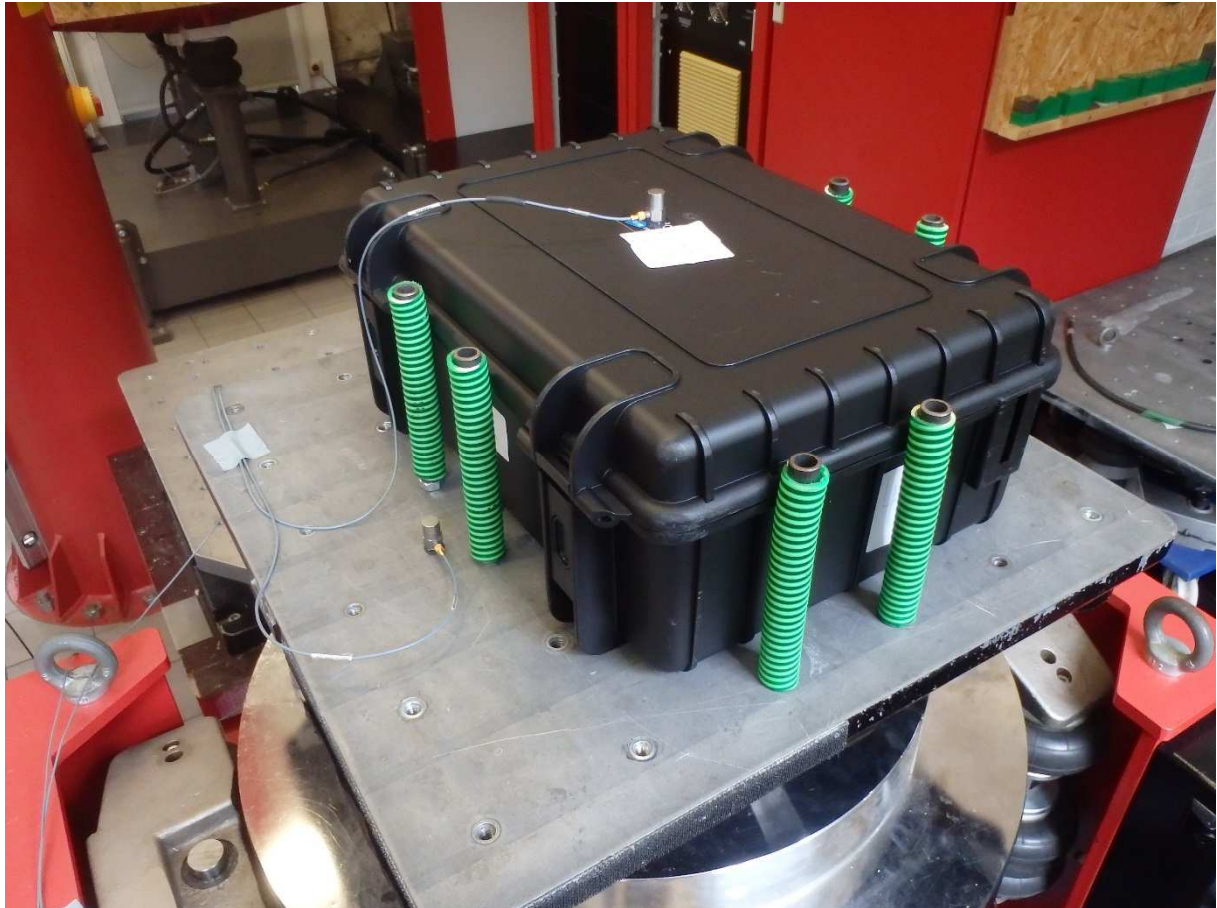
**Illustration 5:** Setup Vibration Tests

According to the specification a resonance search was performed. The frequency range was 5 to 50 Hz and the acceleration was 0.5 g. The sweep rate was 1 octave per minute. 2 Sweeps were performed. Illustration 5 documents the setup for vibration testing.

In conclusion of the resonance search each resonance point was dwelled for 2 hours. A definition of a resonance point was given by the client (2-fold acceleration). The test setup is equal to the search and documented in illustration 5.

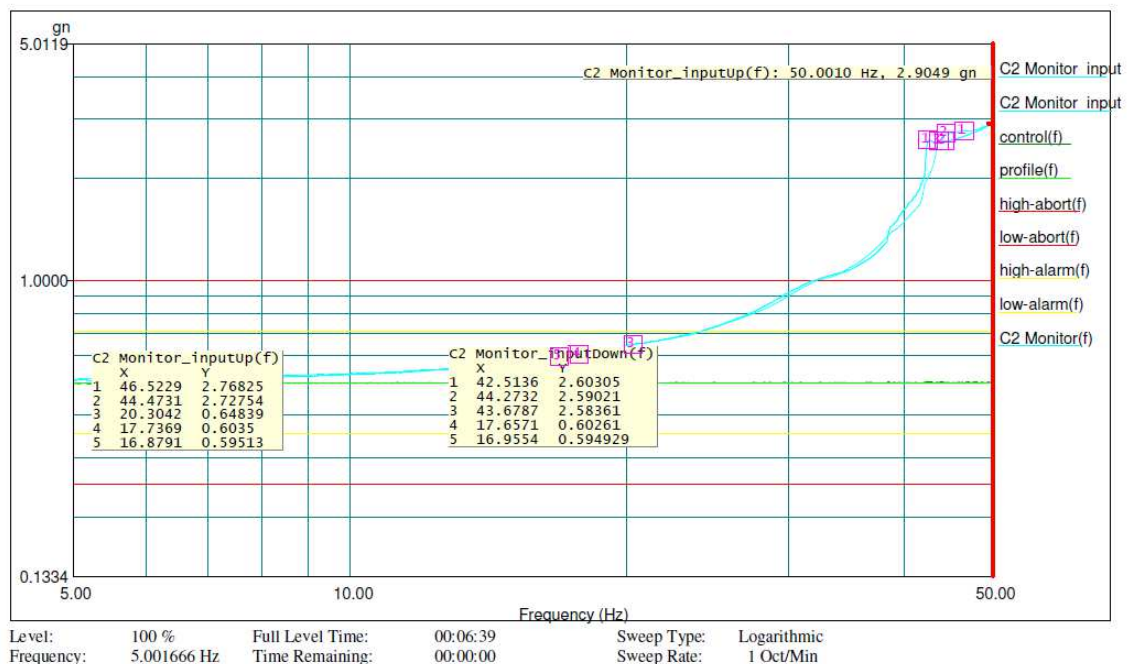
Diagram 1: Resonance Search Test

The test was performed with the parameters from table 2. Diagram 1 documents the test proceeding.

Following resonance points were detected:

Resonance-Frequency and Acceleration-Response			
Acceleration Input 0.50 g			
Axis	Frequency	Acceleration Response	Dwell Time
Z-Axis	42.5 to 46.5 Hz	2.5 to 2.7 g	2 h
	50 Hz	2.9 g	2 h

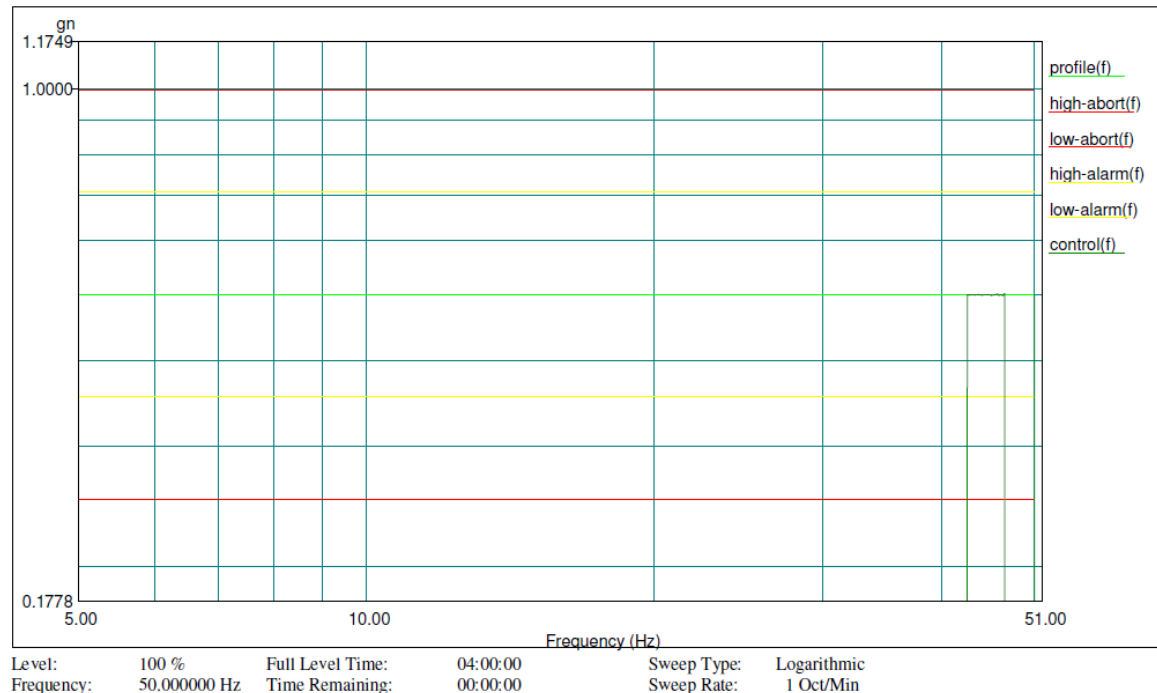
**Diagram 2: Resonance Dwell Test**

The test was performed with the parameters from table 2. No visual changes could be detected after the test. Diagram 2 documents the test proceeding exemplarily.
