TEST REPORT

Project-No.:	17-8981
Test Specimen:	Shipping Unit - Outdoorcase -
Client:	B&W International GmbH Junkendiek 5 49479 Ibbenbühren
Responsible Persons:	Waldemar Masur (B&W International GmbH) Johannes Frick (PAConsult GmbH)

By means of a transport simulation an outdoorcase - Type 4000 - is tested to climatic-, vibration- and shock strains. Furthermore a water resistance test is performed. The transport simulation is performed according to the specification of the client: MIL-STD-810G w/Change 1 [1].

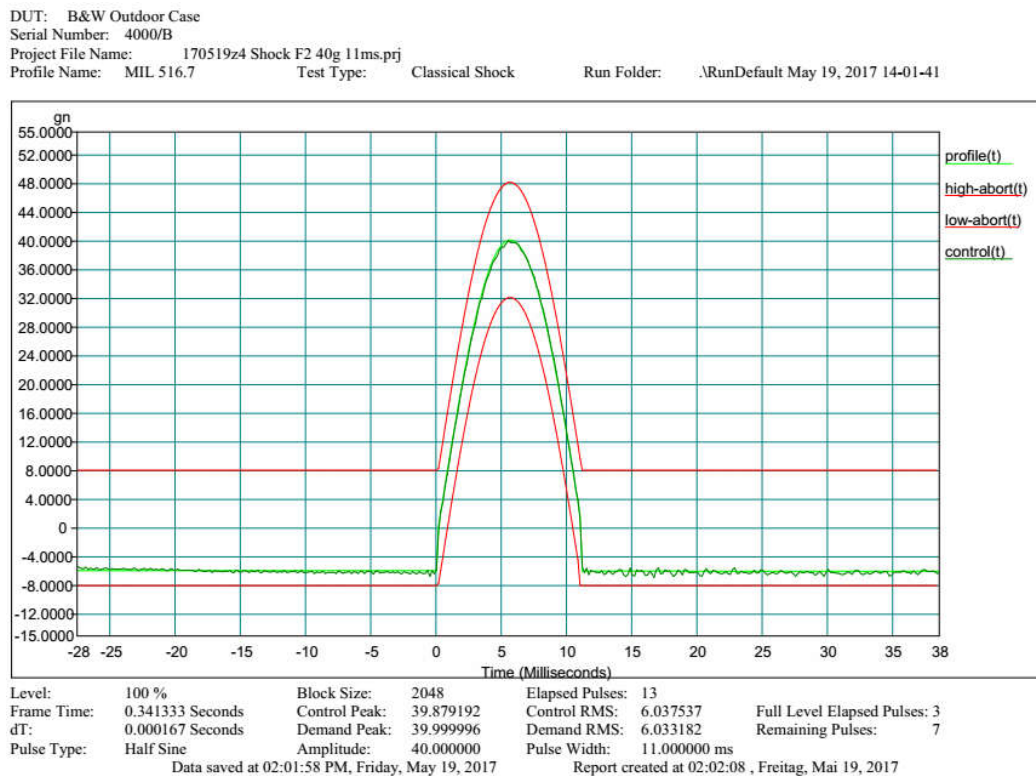
Fig. 16: Positive Shock x-Axis

The test is performed with the specified parameters (see Tab. 2). During the test no visible changes were observed. Fig. 16 to 21 show the shock proceeding.

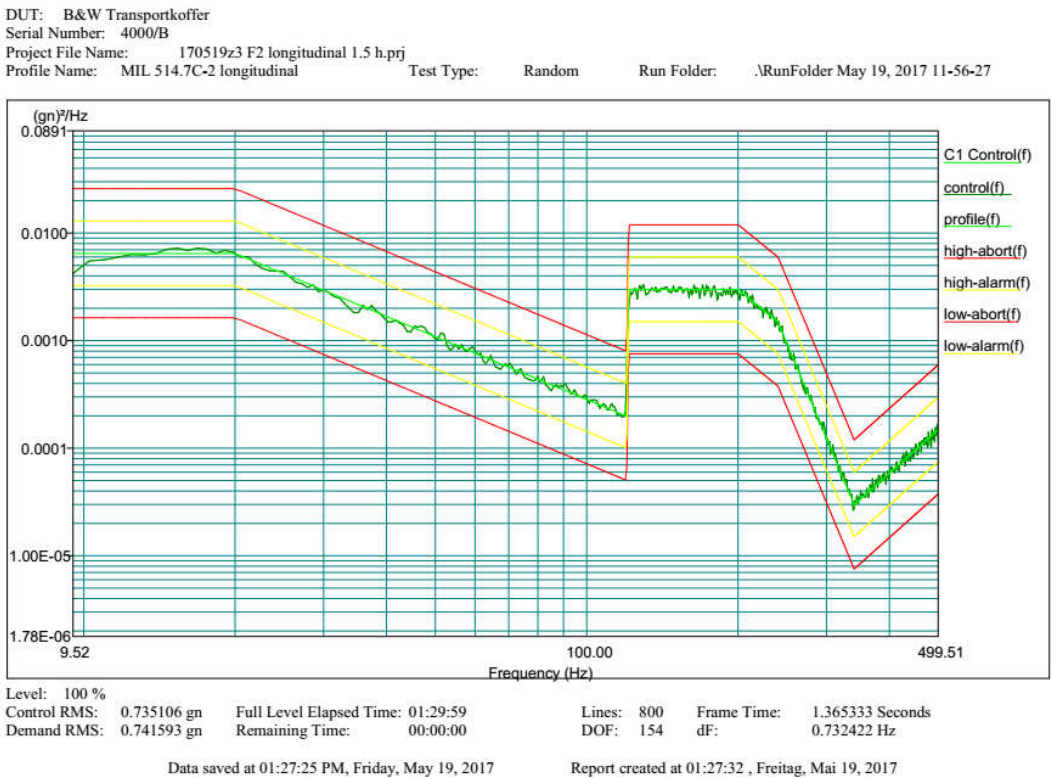
**Fig. 22:** Random Vibration x-Axis

The test is performed with the specified parameters (see Tab. 2). During the test no visible changes were observed. Fig. 22 to 24 show the vibration proceeding.
